Technical Report CHL-98-8
March 1998

Navigation Conditions at Saugus River Floodgate

Prepared for U.S. Army Engineer Division, New England

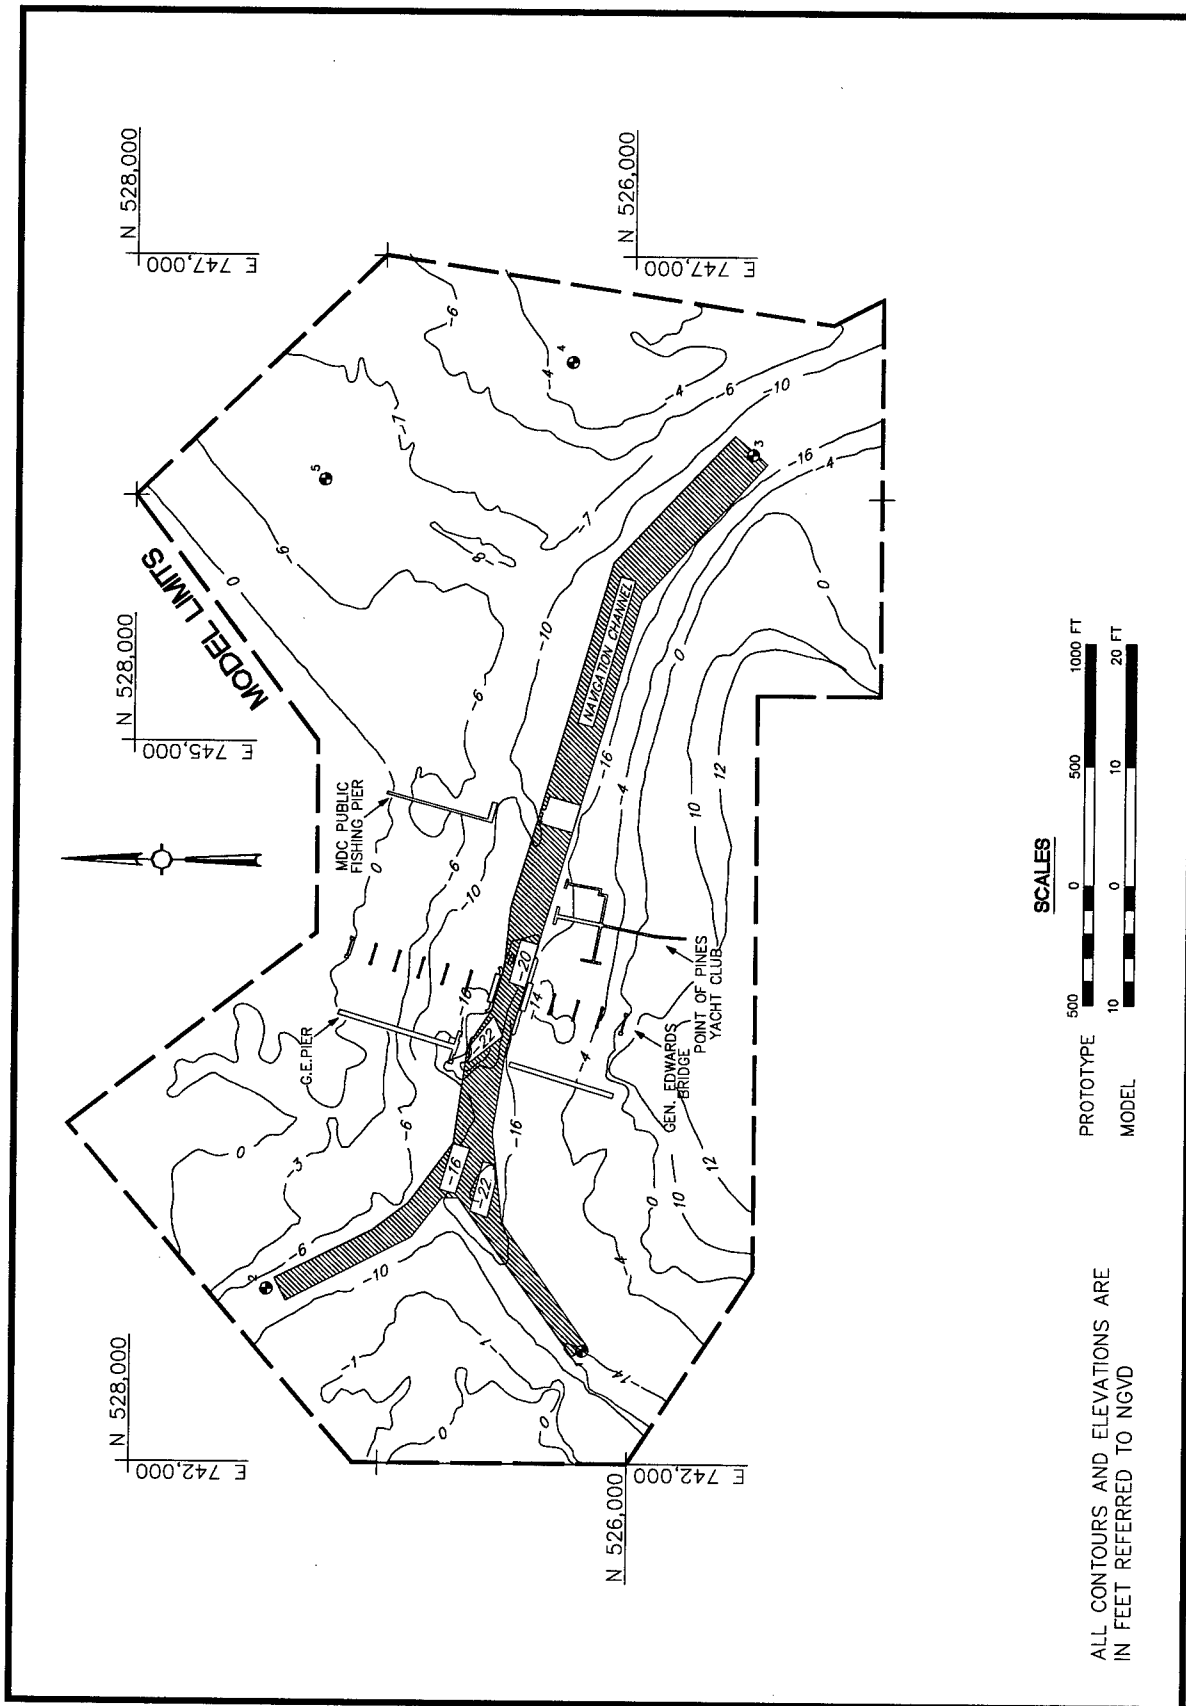
Figure 2. Existing conditions

Existing conditions, shown in Figure 2, consist of the following principal features:

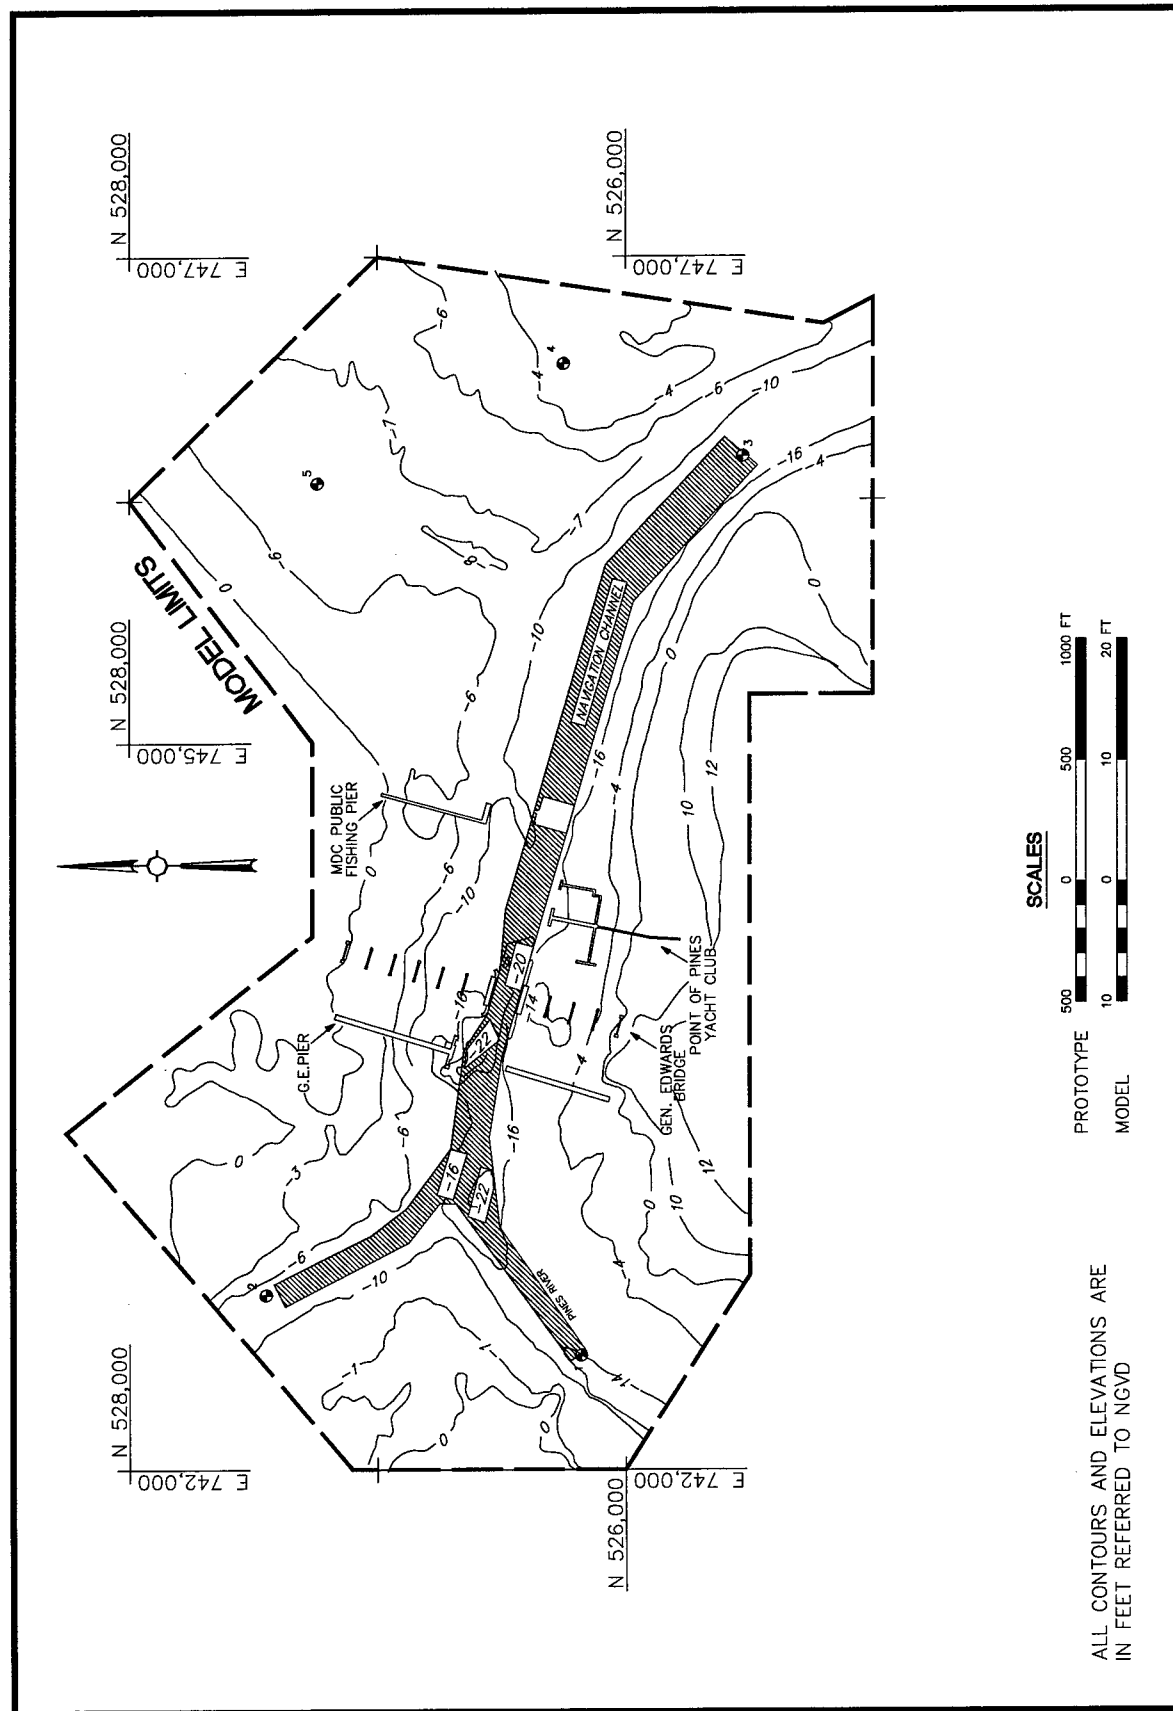
Figure 3. Base conditions

Base conditions, shown in Figure 3, are the same as existing conditions with one exception. Base conditions included the influence of breaching the I-95 embankment. This breaching of the I-95 embankment caused a change in discharges and water-surface elevations for the spring and neap tides compared with those of existing conditions and also affected the timing of flows due to the way the backwater marsh areas were flooded and emptied. The changes in discharge and water-surface elevation were defined under "Test Procedures," on page 6.

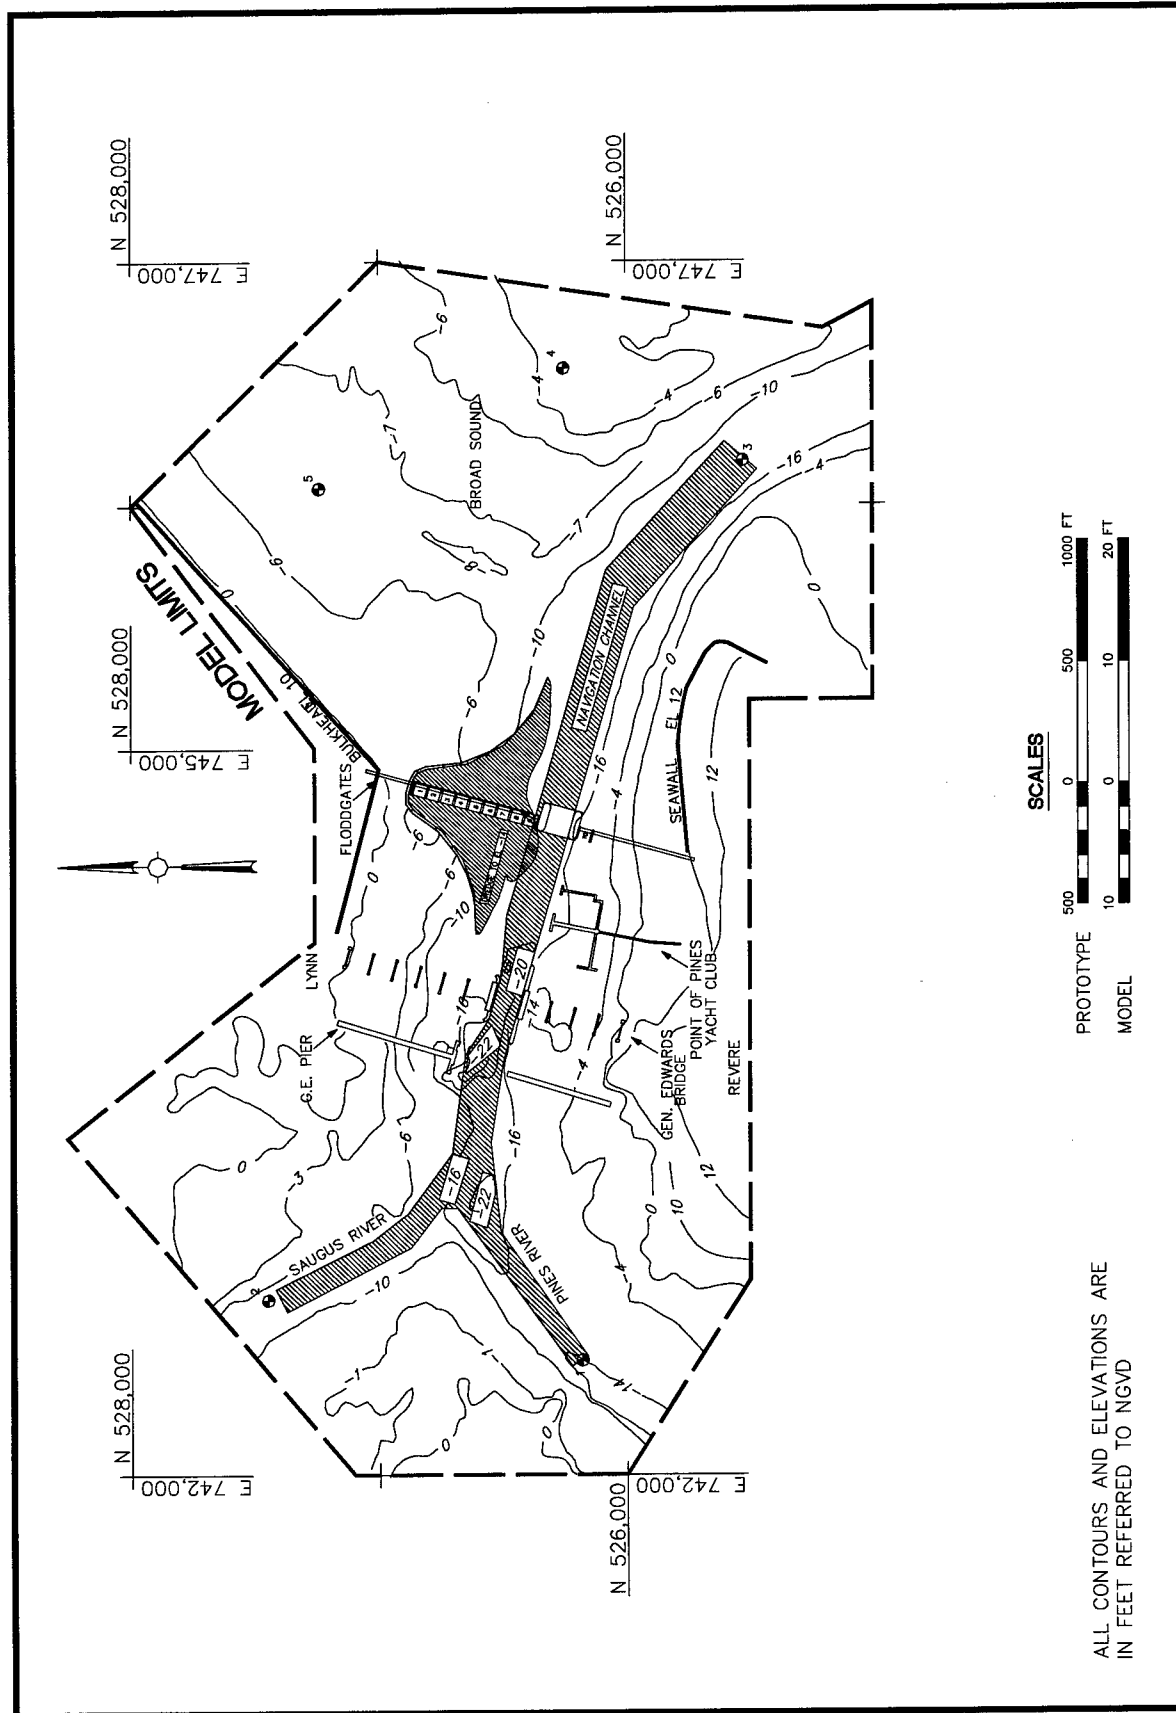
Figure 4. Plan 1

Plan 1, shown in Figure 4, is the same as the base condition with a few exceptions:

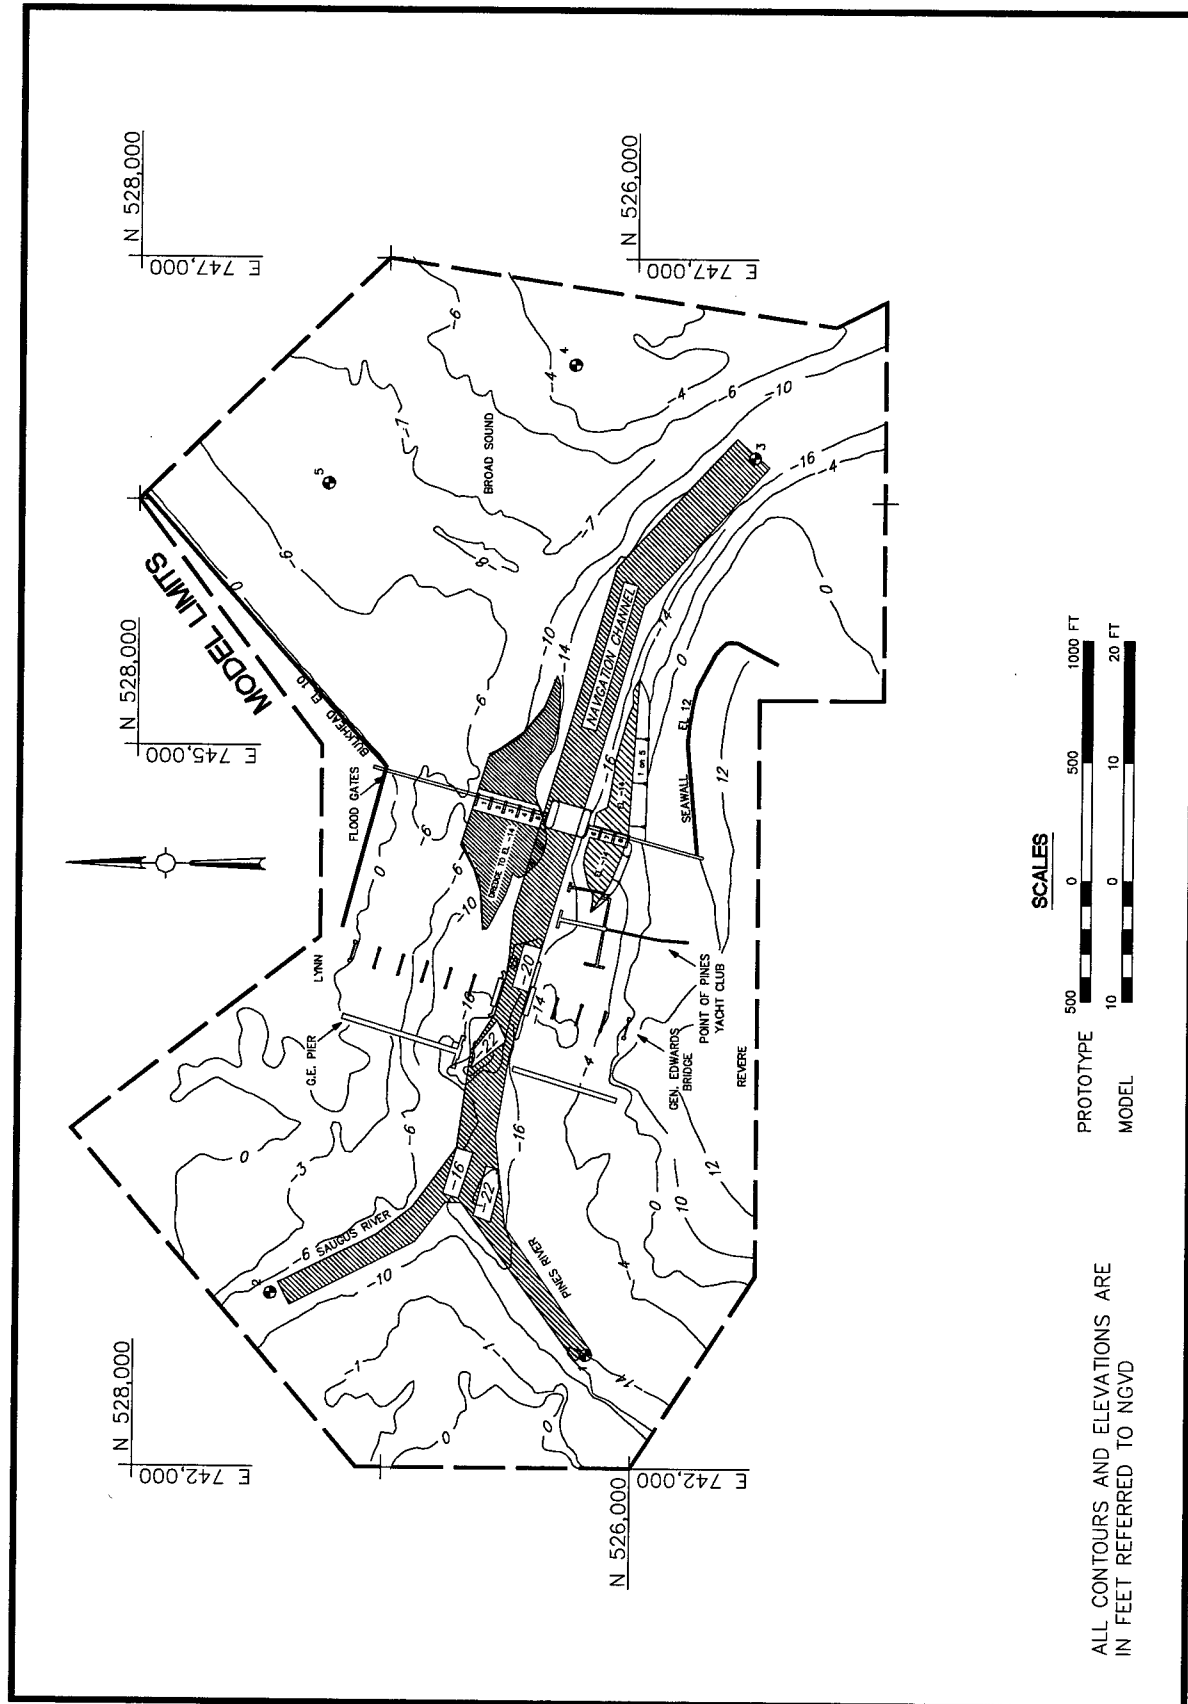
Figure 5. Plan 2

- a. Two additional floodgates were placed on the south side of the navigation gate, for a total of three gates on the south shore.
- b. Four gates were removed on the north side of the navigation gate, for a total of five gates on the north shore.
- c. A dredged approach at el -14 was placed both seaward and inland of the three gates on the south shore.
- d. The area dredged on the north side was reduced such that it was normal to the flood-control structure at gate 1. With Plan 2, the influence of breaching the I-95 embankment was also included, i.e., base boundary conditions.

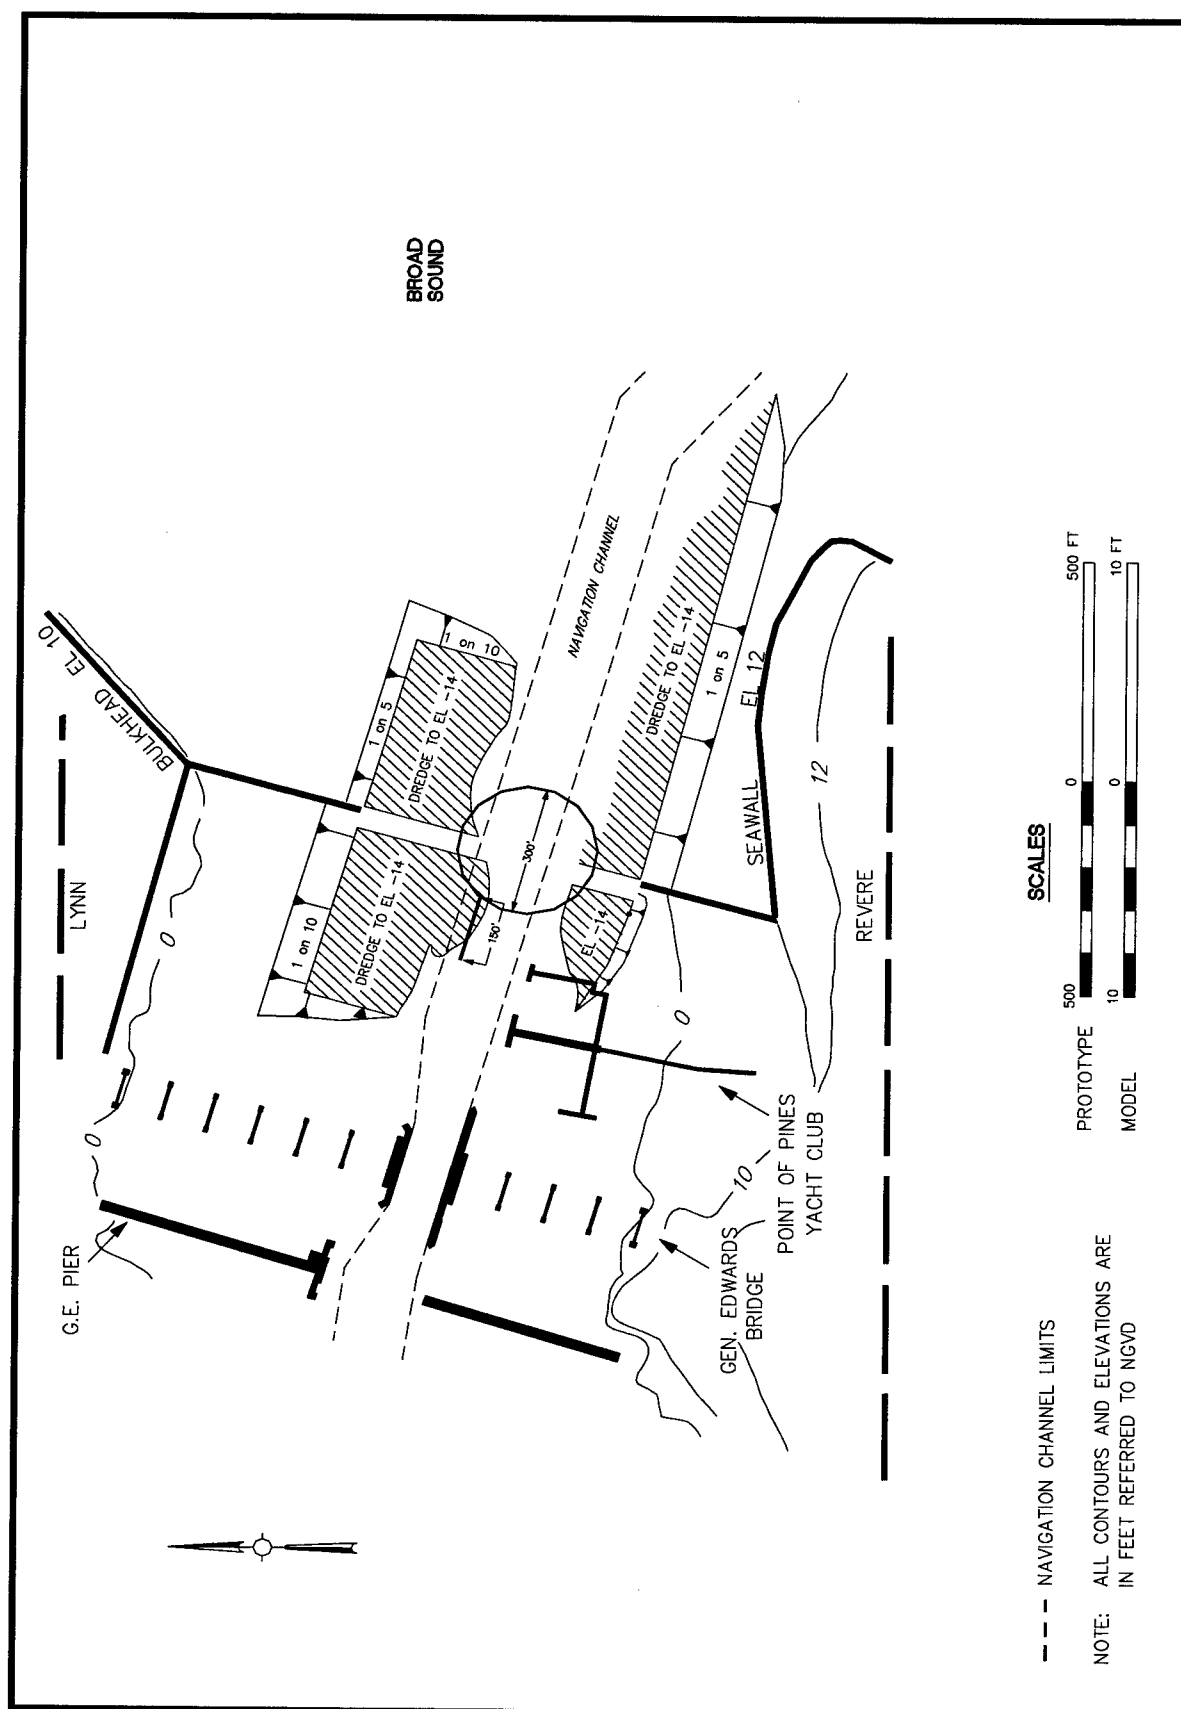
- a. Stage 1, shown in Figure 10, is the construction of a 300-ft-diam circular cofferdam in which the navigation gate would be constructed. A "splitter" wall would be constructed and would extend 150 ft from the outer edge of the circular cofferdam toward the GEB. The splitter wall would be aligned with the center line of the north pier of the navigation gate. The splitter wall would remain in place during the entire construction of the project. Also, the concrete gravity walls extending from the north and south shores out to the "end" tainter gates would be constructed simultaneously with the circular cofferdam.
- b. Stage 2, shown in Figure 11, would begin after the circular cofferdam is removed. Stage 2 would require construction of a square cofferdam

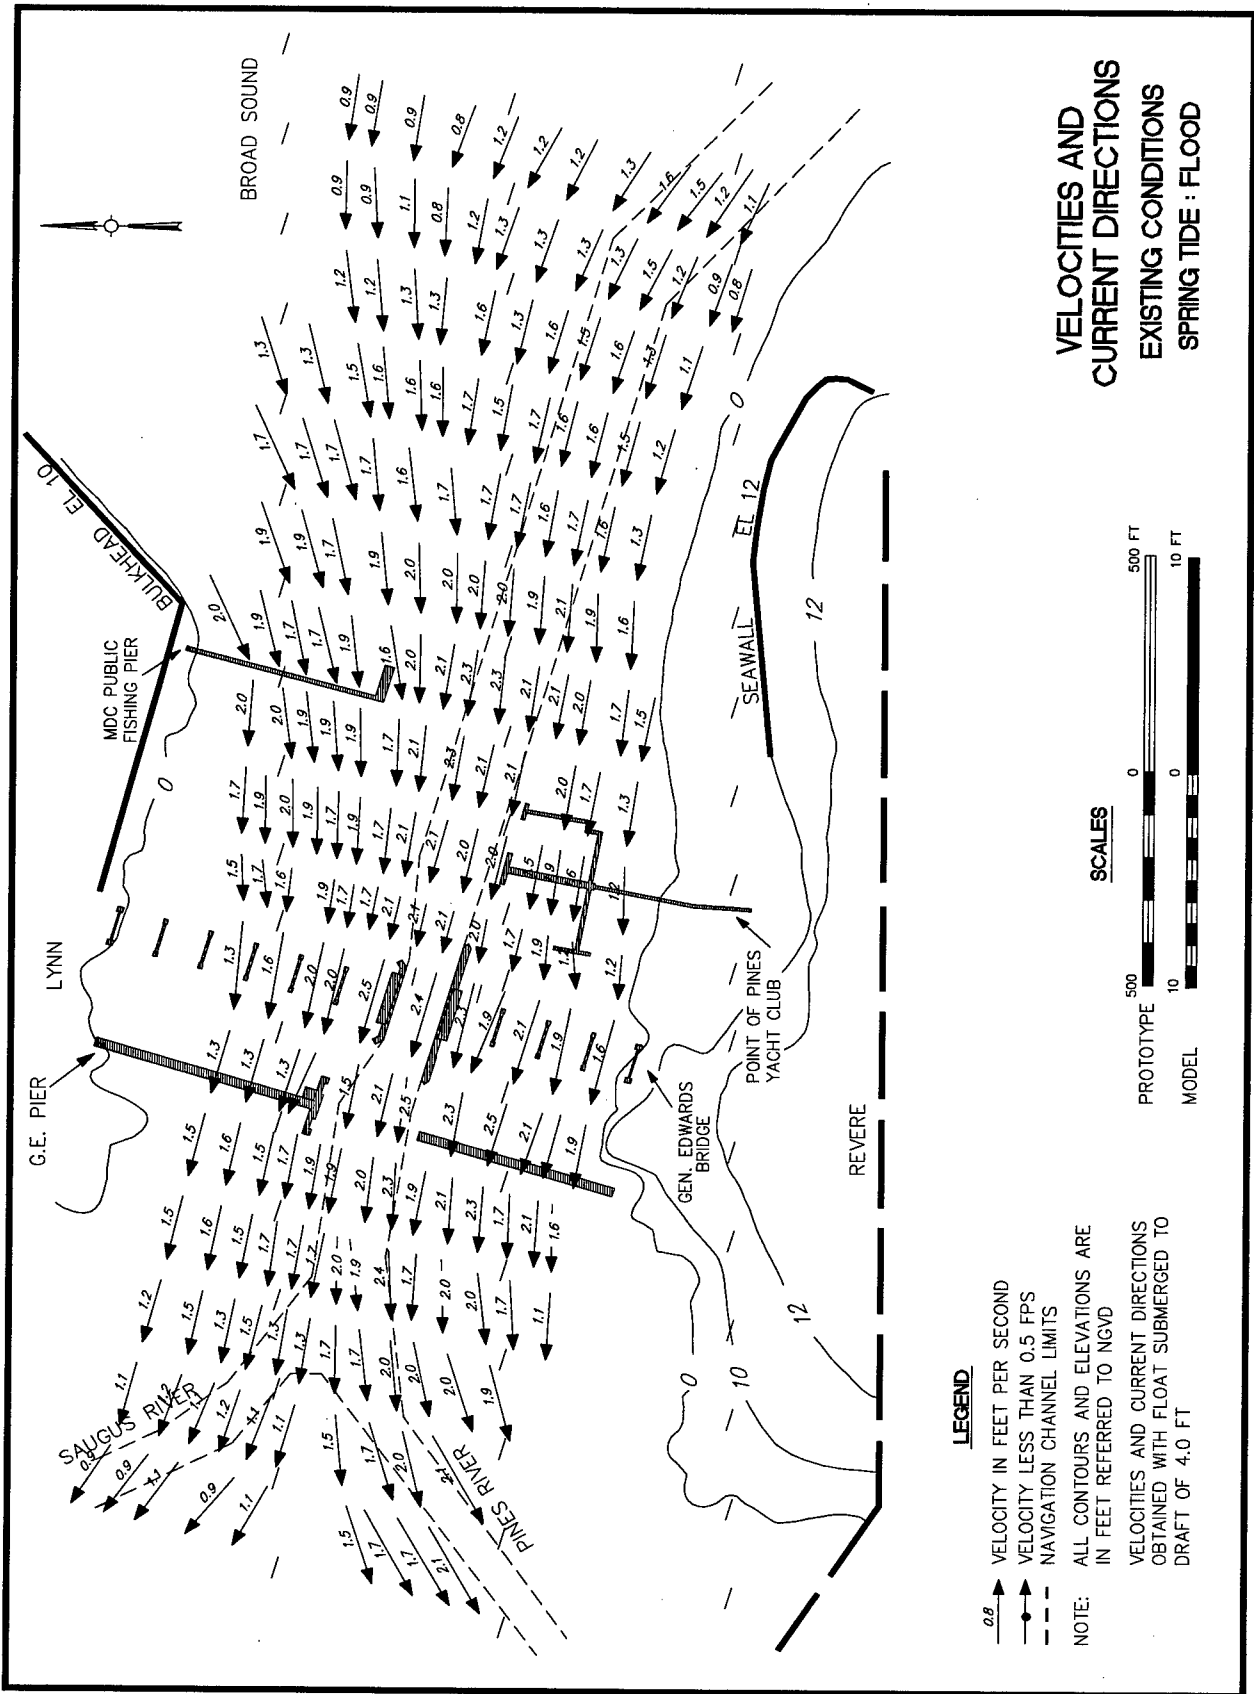
Plate 2

Current direction and velocities. Current direction and velocity data are shown in Plates 1-4. Current direction and velocity data for flood flow with the neap and spring tides are shown in Plates 1 and 2. These data indicated that when flow is moving in the flood direction, the flow from Broad Sound is "funneled" into and across the navigation channel. The maximum velocity of the flow moving across the navigation channel was about 2.3 fps¹ with the spring tide and occurred in the general vicinity of the MDC fishing pier; a shallow area extends from the north bank almost to the navigation channel in this area. With the neap tide, the same trend was observed. However, the maximum velocity of the flow moving across the navigation channel was about 0.9 fps. The maximum velocity of flow moving in the flood direction generally occurred in or near the navigation span of the GEB and was 1.2 fps and 2.5 fps with the neap tide and spring tide, respectively.

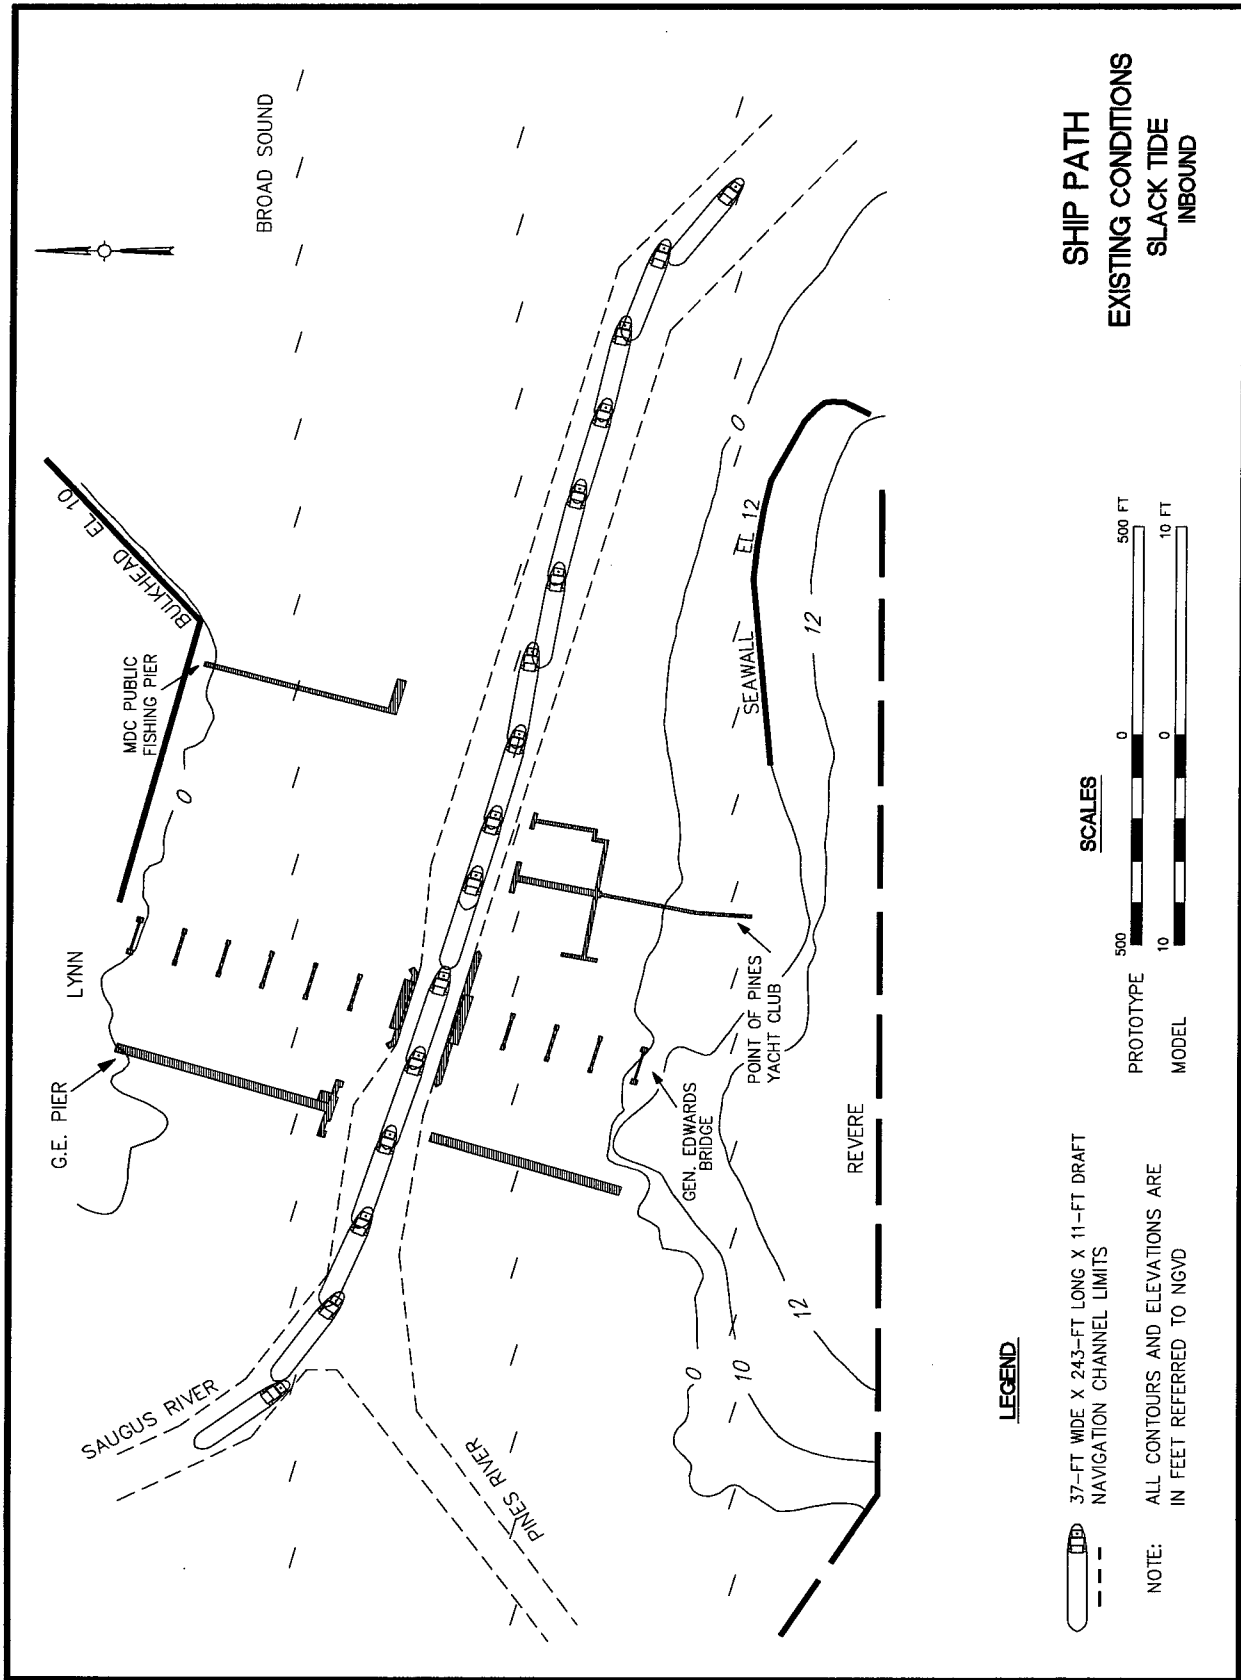
Plate 5

Navigation conditions. Navigation conditions were evaluated using the model tanker (Plates 5-14). Navigation conditions were satisfactory with slack tide conditions for inbound and outbound tankers (Plates 5 and 6). Inbound and outbound tankers could approach the navigation span of the GEB and pass through the navigation span with no major difficulties.

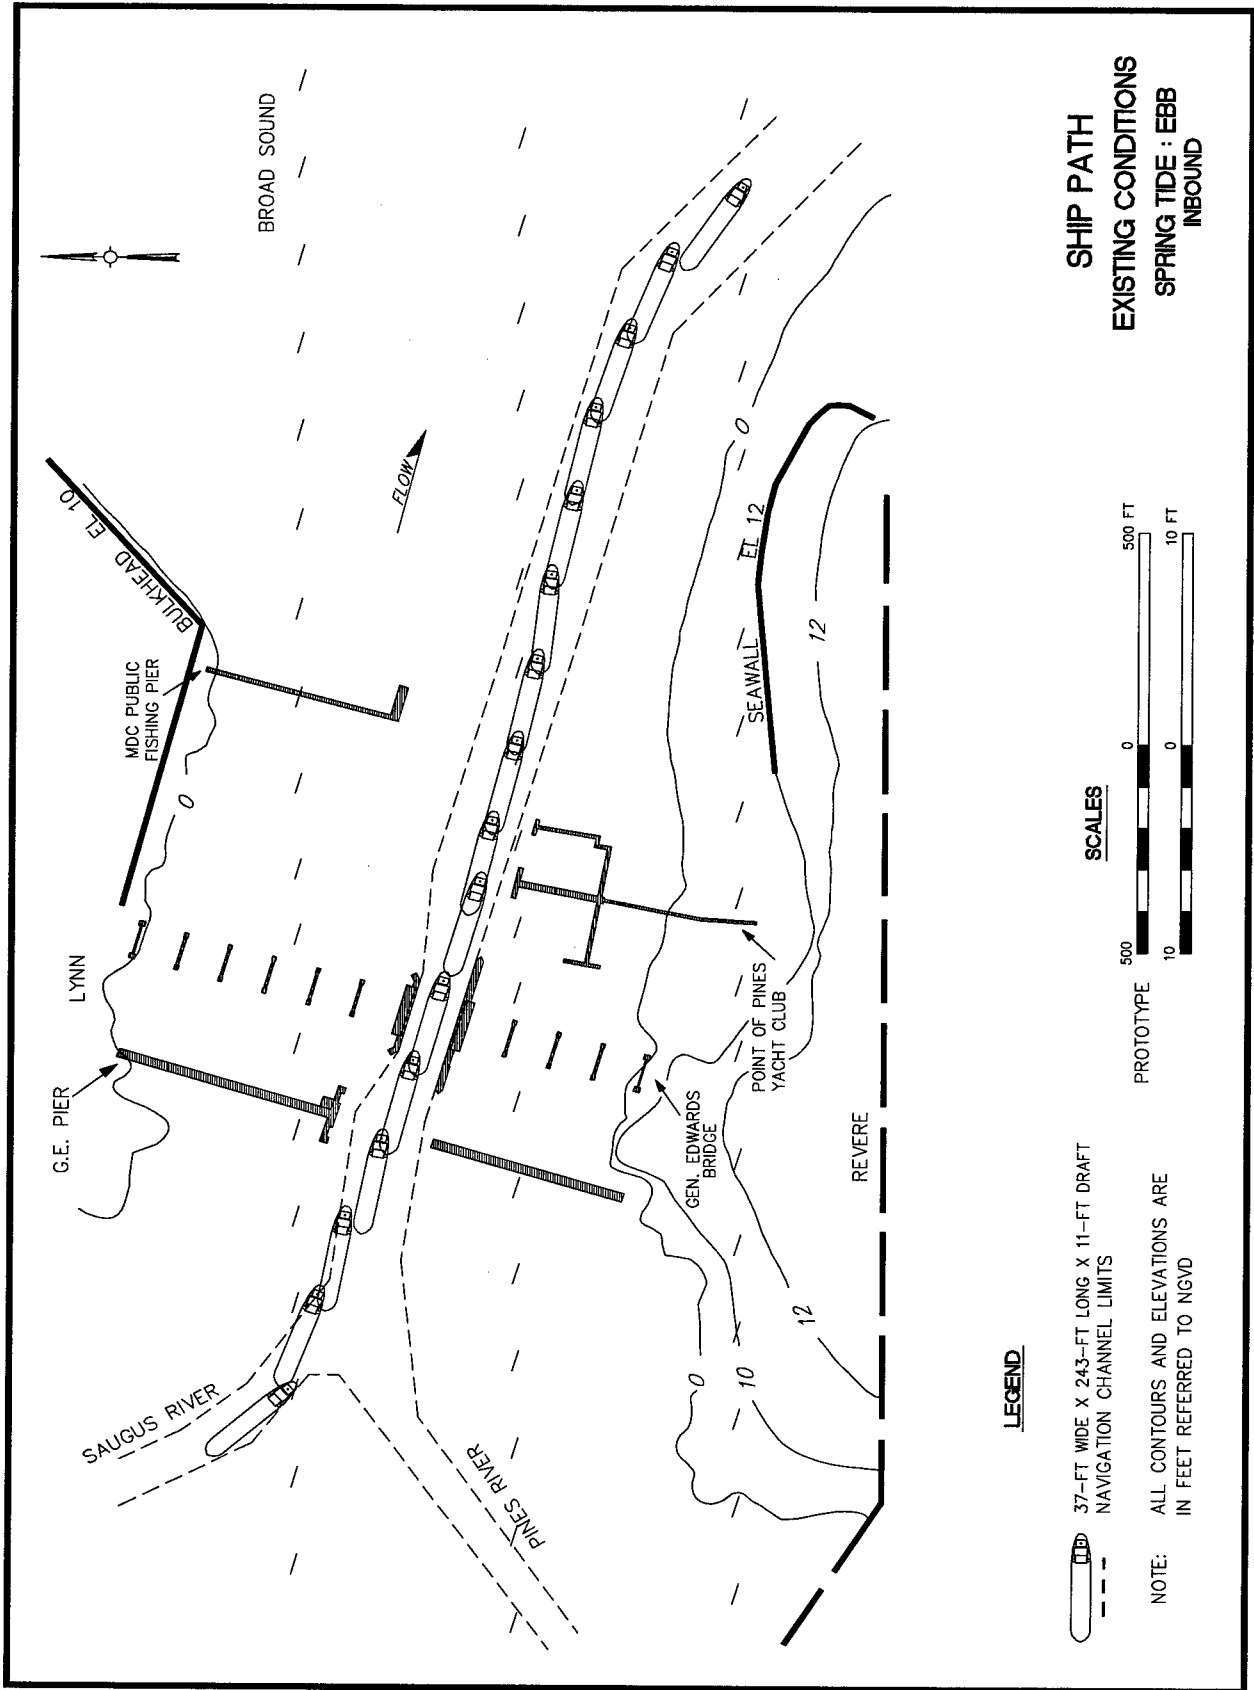
Plate 12

With the neap and spring tides and flow in the ebb direction, inbound tankers could align with the currents seaward of the GEB. Inbound tankers were required to approach the navigation span of the GEB at a slight angle due to the current pattern in the navigation channel. Inbound tankers had a tendency to be moved toward the PPYC. Once through the navigation span of the GEB, inbound tankers experienced a tendency to be moved toward the G.E. Pier by the currents moving out of the Pines River (Plates 11 and 12). Also, making the turn into the Saugus River was difficult due to the flow patterns in the confluence of the two rivers. With the spring tide, navigation conditions for inbound tankers were more difficult due to higher discharge.

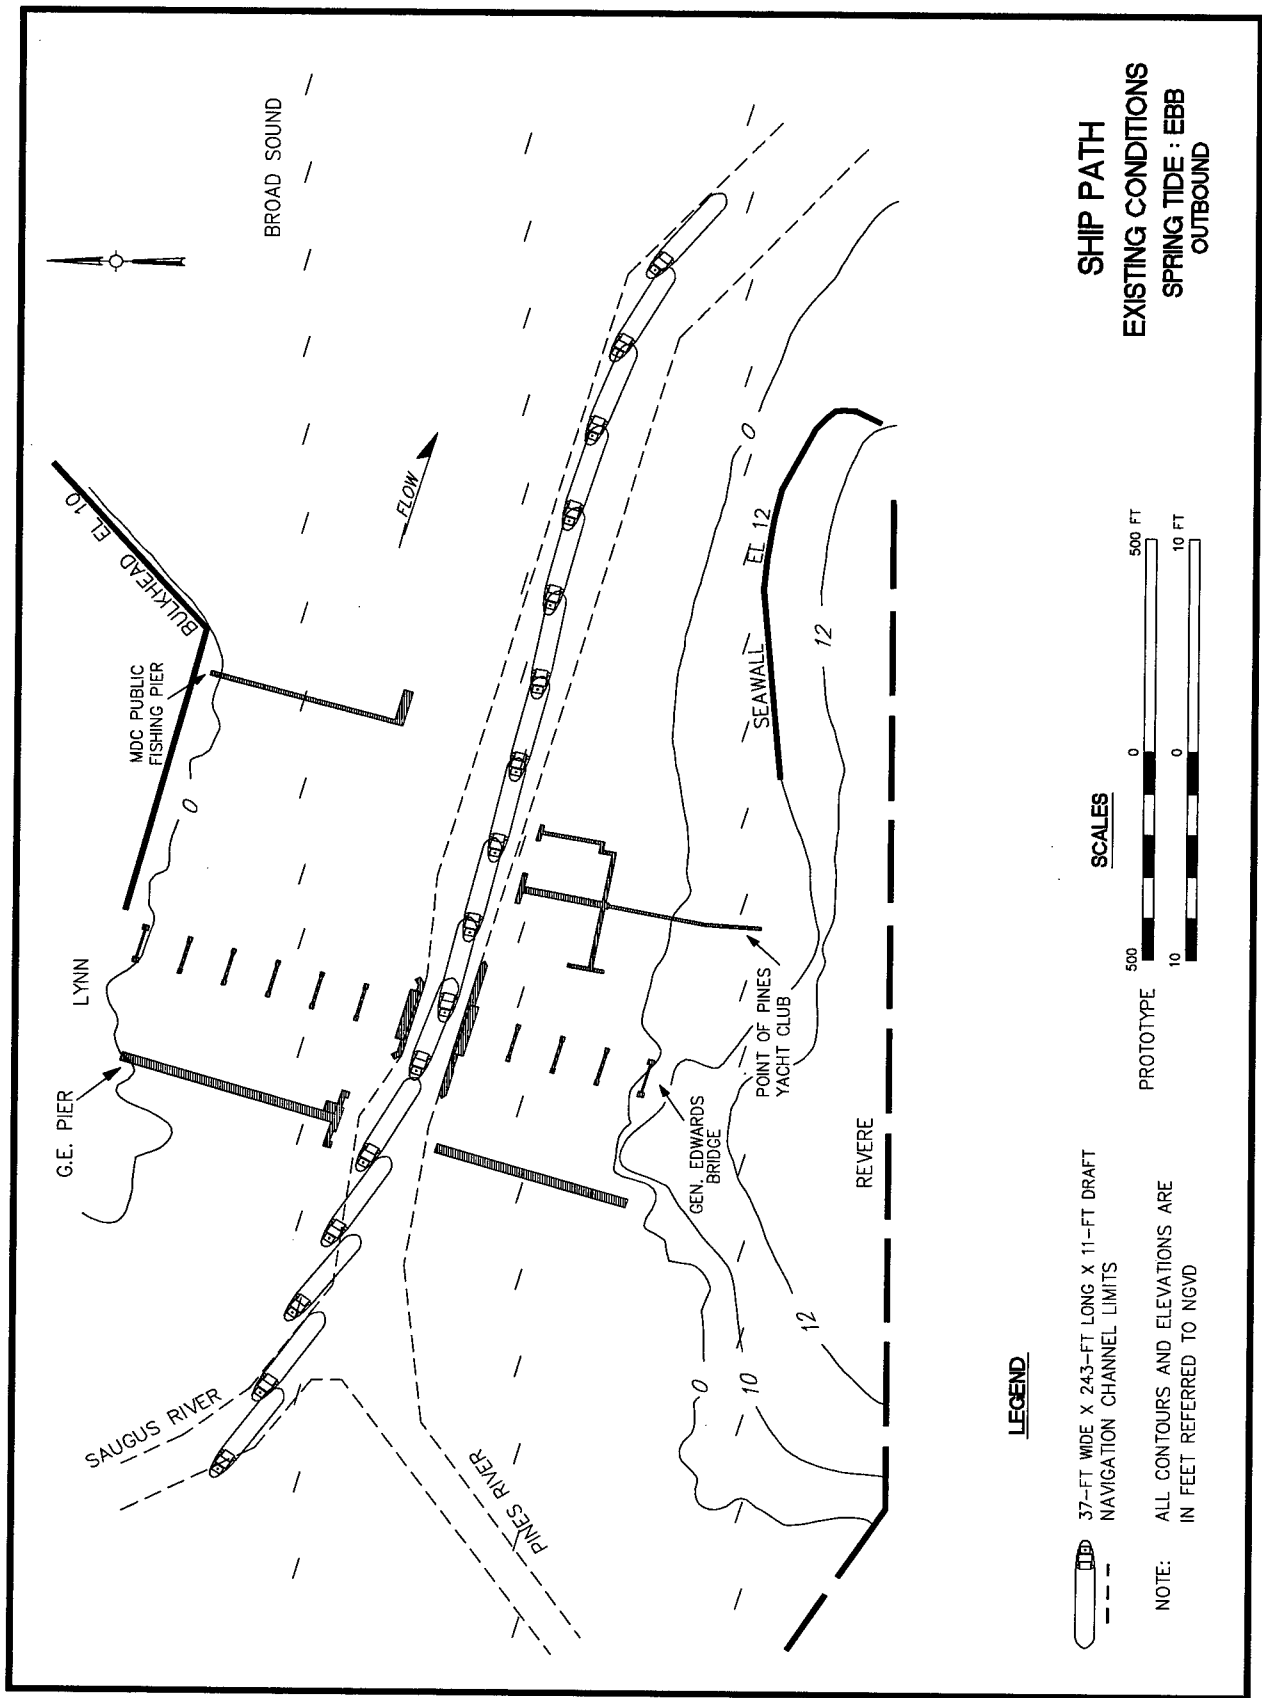
Plate 14

With the neap tide and spring tide and flow moving in the ebb direction, navigation conditions were difficult for outbound tankers and in particular with the spring tide (Plates 13 and 14). The flow moving out of the Pines River tended to push outbound tankers leaving the Saugus River toward the G.E. Pier and out of alignment with the navigation span of the GEB (Plate 14). After passing through the GEB, outbound tankers experienced a slight tendency to be moved toward the PPYC.

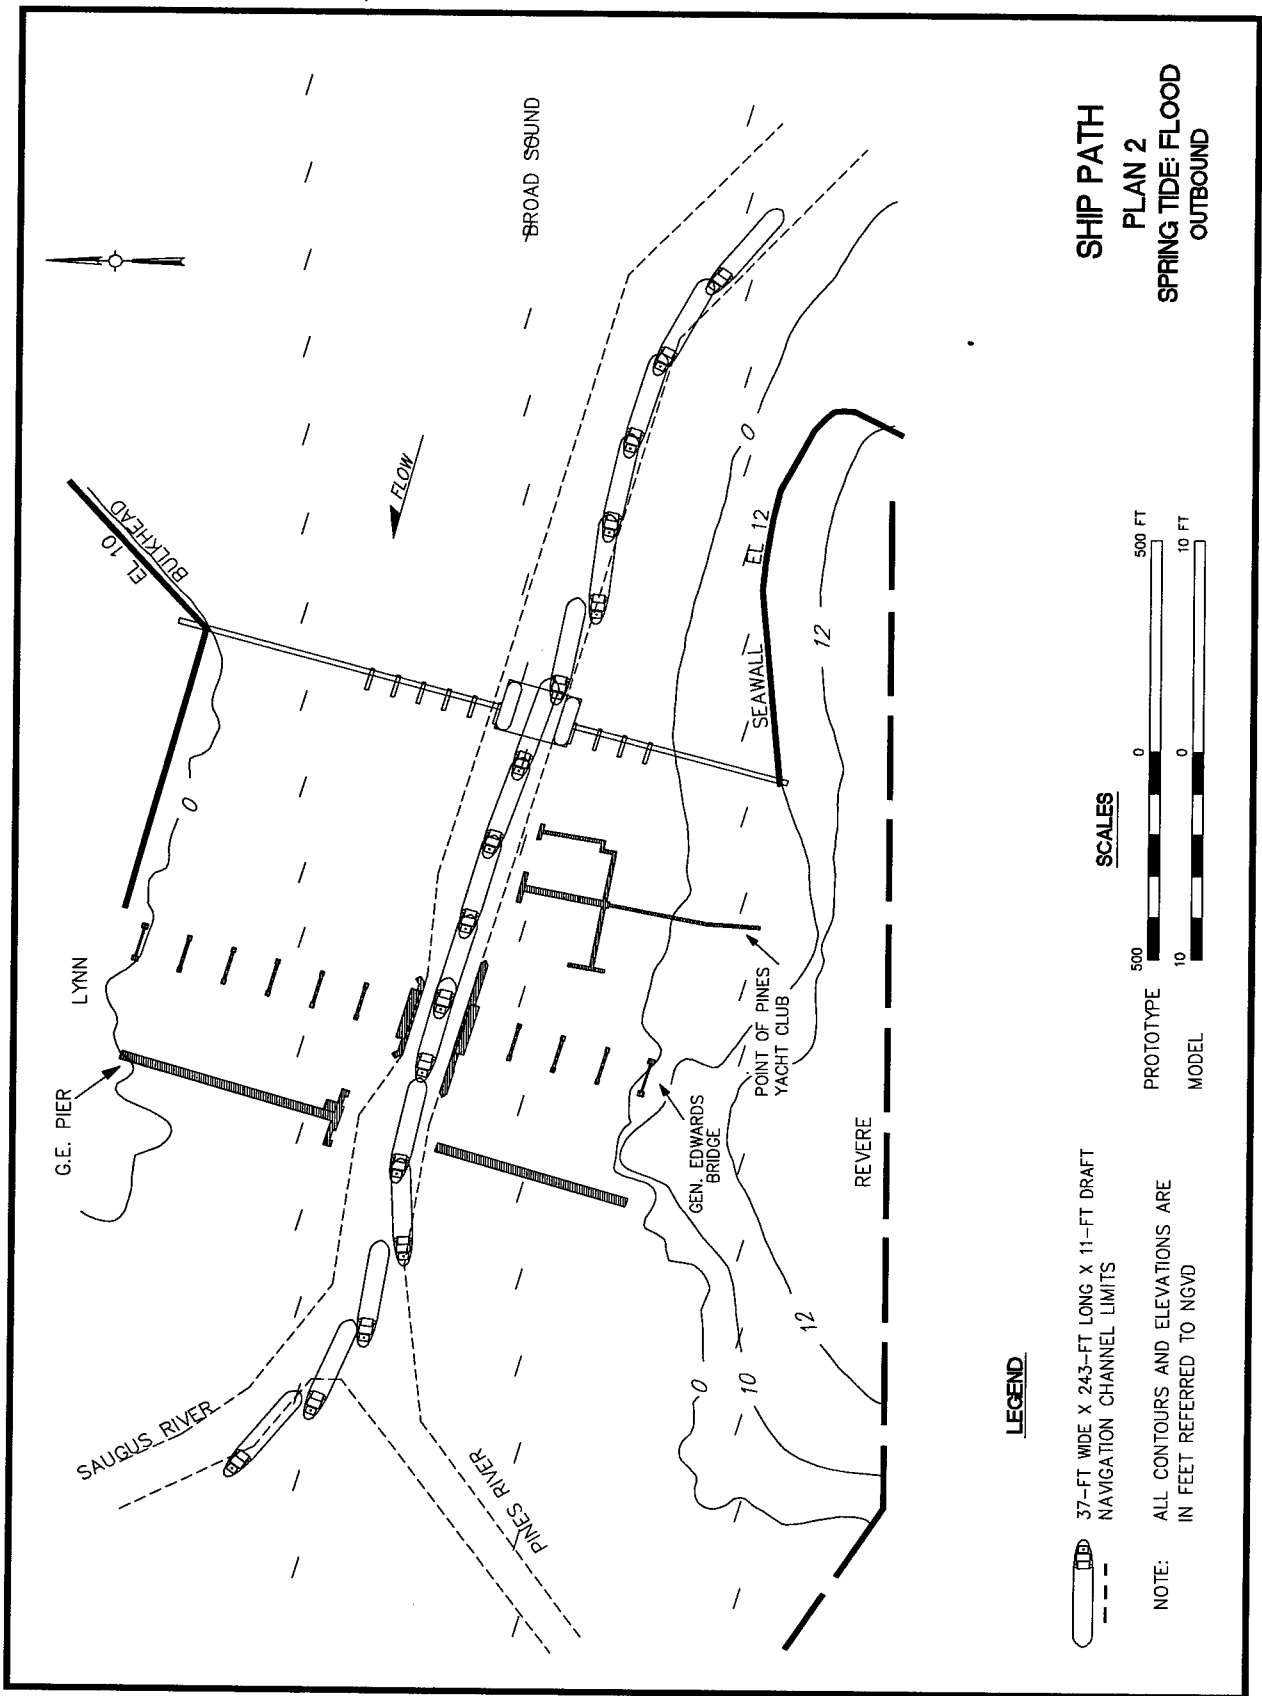
Plate 32

With spring tide and flood flow, navigation conditions were improved compared with those of Plan 1 and were considered satisfactory for outbound tankers provided sufficient maneuvering area is provided south and seaward of the navigation gate and south of the navigation channel. Outbound tankers could approach and pass through the navigation span of the GEB, align with the navigation gate, and exit the navigation gate with no significant difficulties (Plate 32). Navigation conditions exiting the flood-control structure were similar to those observed with Plan 1. Outbound tankers were required to set into the crosscurrents (flow moving toward the south gates) to complete the transit of the navigation gate. Because the ship could not begin adjusting to the currents while in the gate structure, the ship drifted to the south and out of the authorized
